## **Longochi Water Supply Association (LOWASA) Rehabilitation Phase 1 Proposal**

## **2.0 Longochi Water Project in Marangu East Ward.**

## **2.5.0 Longochi Water Supply Project Phase 1 Rehabilitation Requirements**

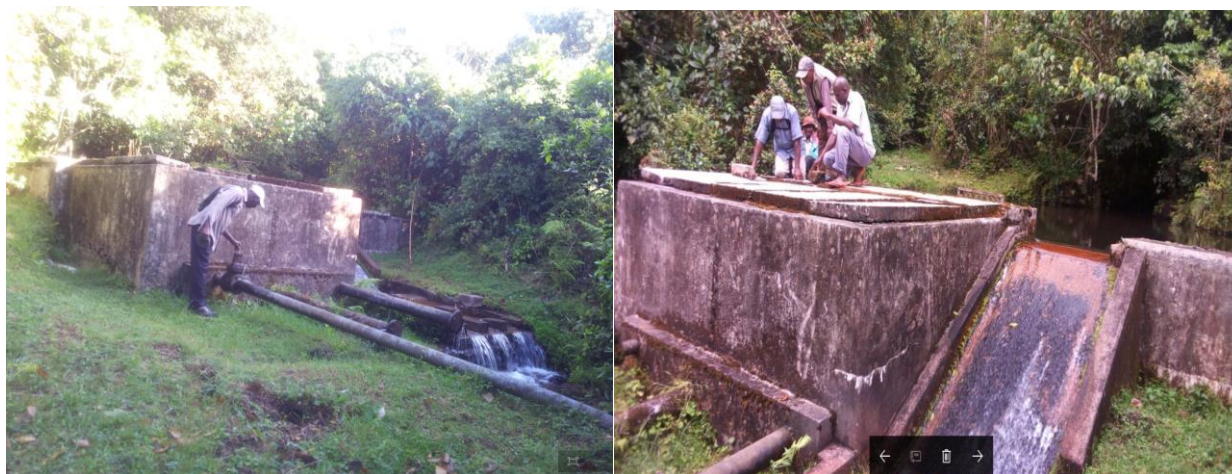
The intake is well constructed but with poor coagulation and sedimentation partition with small aluminum strainer (having very big holes). The sump and the dividing walls are not supporting sedimentations and also the strainer allows big particles of tree parts and tree leaves penetrated to the main supply line which sometimes results into blocking of water flow. The Supply line is 4 inches, starting with GS then PVC of 4' which goes for a distance of about 800 meters. From 800 meters, it is connected with 3 inches PVC mixed with some GS to about 2200 meters where the distribution tank is built. From the connection where the 4 inches pipe ends, 3 inches' pipe is connected. At this connection there is a major leakage where more than ½ of the water produced is lost through this major leakage.

*Photo 1&2 shows condition of the Project's intake environment*

- Constructing of a new aluminum strainer shield of 10 meters long with a width of 2 meters and concrete side walls for sedimentation and filtering stage 1.
- Restructuring stream walls towards the Sump by establishing concrete walls to reduce muds towards the sump
- Consolidation of sedimentations chamber number 2 to reduce medium sediments which will go together with establishing new washout chamber.
- Placement of filters in all chambers (3) as well as restructuring all washouts in each chamber.

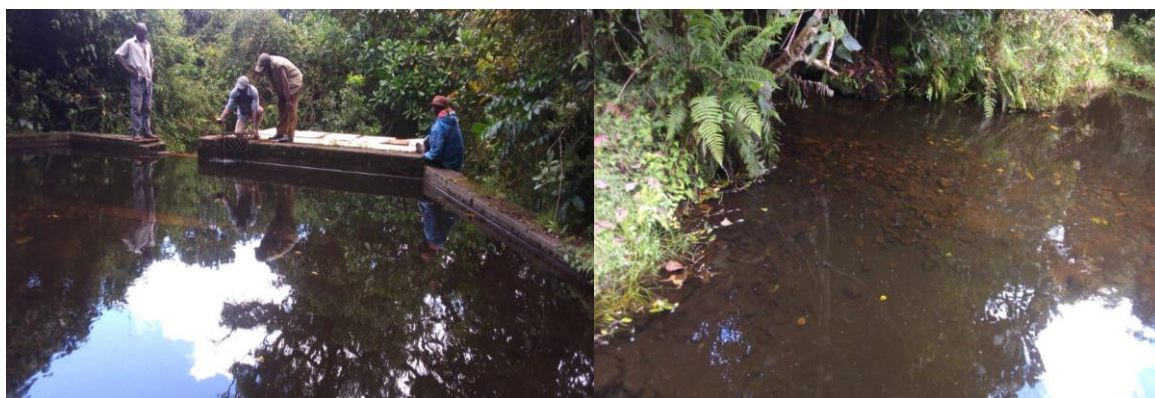
*The Intake where we need construct the aluminum strainer and placement of some water filters*

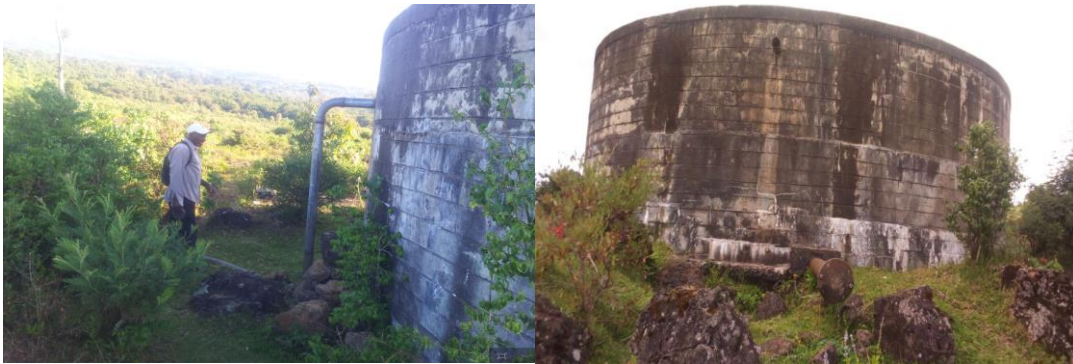
*LOWASA project 100,000 liters' masonry tank from its inlet to washout., where the propose rehabilitation phase 1 will end while waiting for phase 2 which include Building 3 break pressure tanks of 20 m<sup>3</sup> each*

The task will be completed by creating second inlet to the 100,000 (10m<sup>3</sup>) liters' tank. In future we are planning to install Chlorine treatment system at the inlet so as to disinfect the water.
